DEPARTMENT OF TRANSPORTATION

Quality Assurance and Source Inspection

Contract #: 04-0120F4Cty: SF/ALA Rte: 80 PM: 13.2/13.9File #: 69.28**WELDING INSPECTION REPORT****Resident Engineer:**Siegenthaler, Peter**Address:** 333 Burma Road**City:** Oakland, CA 94607**Report No:** WIR-017551**Date Inspected:** 12-Oct-2010**Project Name:** SAS Superstructure**OSM Arrival Time:** 700**Prime Contractor:** American Bridge/Fluor Enterprises, a JV**OSM Departure Time:** 1900**Contractor:** Zhenhua Port Machinery Company, Ltd (ZPMC), Changxing Island **Location:** Shanghai, China**CWI Name:** Mr.Qiu Wen.**CWI Present:** Yes No**Inspected CWI report:** Yes No N/A**Rod Oven in Use:** Yes No N/A**Electrode to specification:** Yes No N/A**Weld Procedures Followed:** Yes No N/A**Qualified Welders:** Yes No N/A**Verified Joint Fit-up:** Yes No N/A**Approved Drawings:** Yes No N/A**Approved WPS:** Yes No N/A**Delayed / Cancelled:** Yes No N/A**Bridge No:** 34-0006**Component:** Tower and Orthotropic Box Girder (OBG)**Summary of Items Observed:**

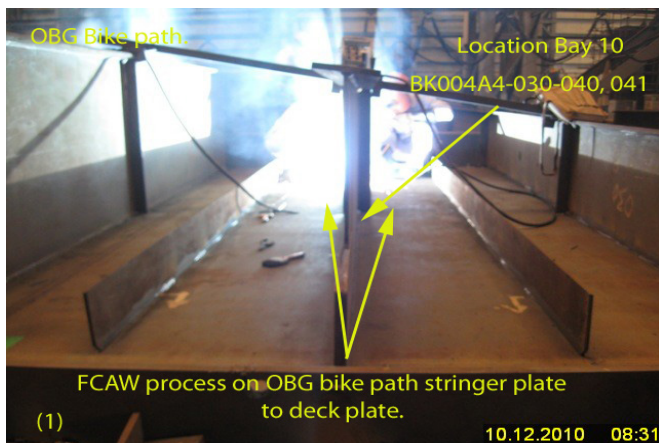
This QA Inspector observed ZPMC qualified welding personnel identified as 057180, 040302, Perform Flux Core Arc Welding (FCAW) on OBG bike path stringer plate to deck plate. Joint identified as BK004A4-030-040, 041. ZPMC QC Identified as Li Peng fei. The welding parameters as measured using QC's calibrated instrument appeared to be in general compliance with WPS-B-T-2132. For more information see below attached picture number 1.

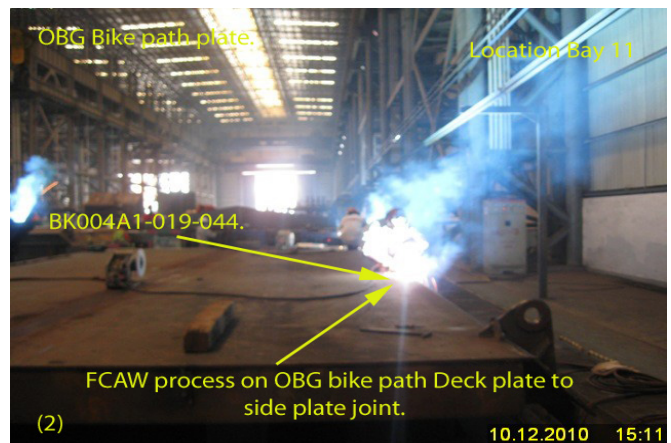
This QA Inspector observed ZPMC qualified welding personnel identified as 040759, 040704, Perform Flux Core Arc Welding (FCAW) on OBG bike path side plate. Joint identified as BK004A1-019-044. ZPMC QC Identified as Shao Hai Lang. The welding parameters as measured using QC's calibrated instrument appeared to be in general compliance with WPS-B-T-2231-B-U2-F. For more information see below attached picture number 2.
